**Flood Control Project Maintenance
Levee Inspections**

Fall 2011 Levee Maintenance Deficiency Summary Report

Sacramento River Basin

Sutter Maintenance Yard East Levee Sutter Bypass

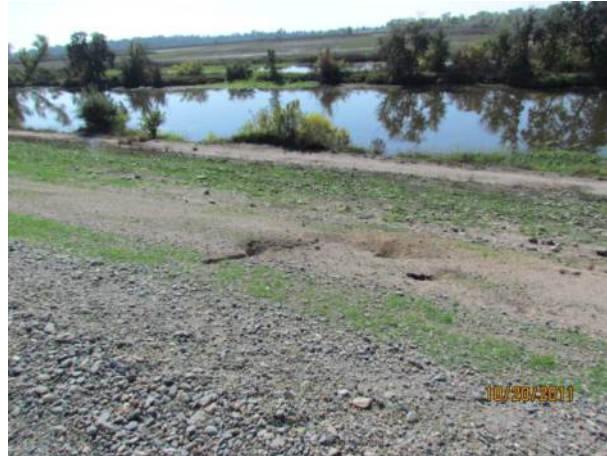
Levee Mile Report Line	2
Start Levee Mile	3.84
End Levee Mile	3.84
Location	Water Side
Category	Earthen Levee
Item	Animal Control

View of the rodent holes along the W/S slope.

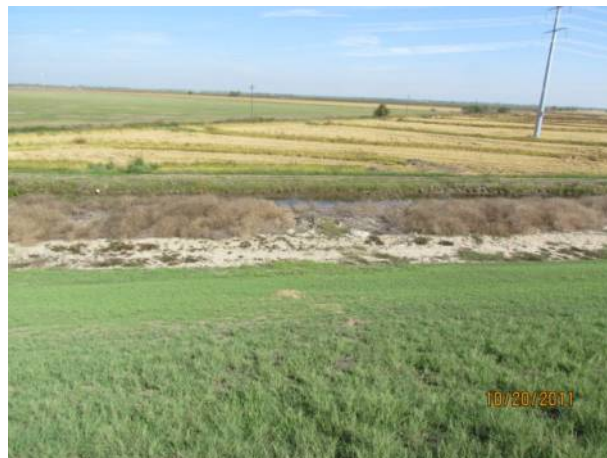
Levee Mile Report Line	11
Start Levee Mile	16.40
End Levee Mile	16.40
Location	Land Side
Category	Earthen Levee
Item	Animal Control

View of the rodent holes along the L/S slope.

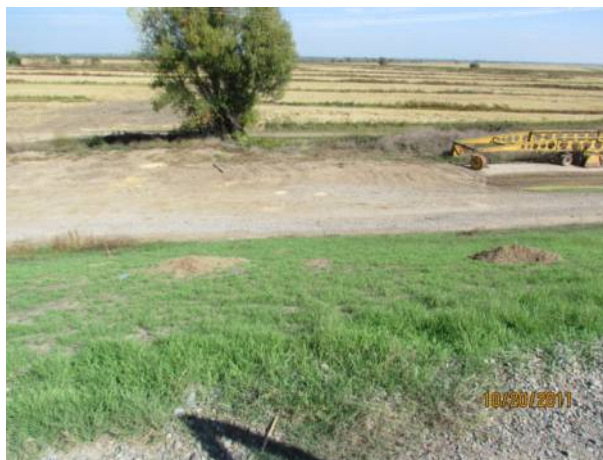
Levee Mile Report Line	12
Start Levee Mile	16.59
End Levee Mile	16.59
Location	Land Side
Category	Earthen Levee
Item	Animal Control

View of the rodent holes along the L/S slope.

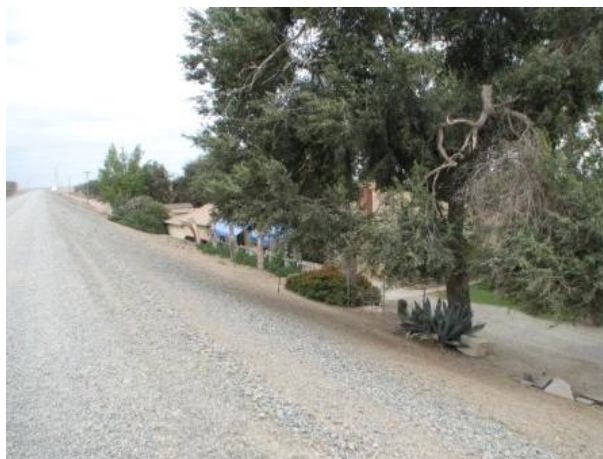
Levee Mile Report Line	14
Start Levee Mile	20.64
End Levee Mile	20.64
Location	Land Side
Category	Earthen Levee
Item	Encroachments

View of the building next to the landside toe of the levee.
